Wear Particles of Single-Crystal Silicon Carbide in Vacuum

NASA Technical Paper 1624

Kazuhisa Miyoshi and Donald H. Buckley
Lewis Research Center
Cleveland, Ohio

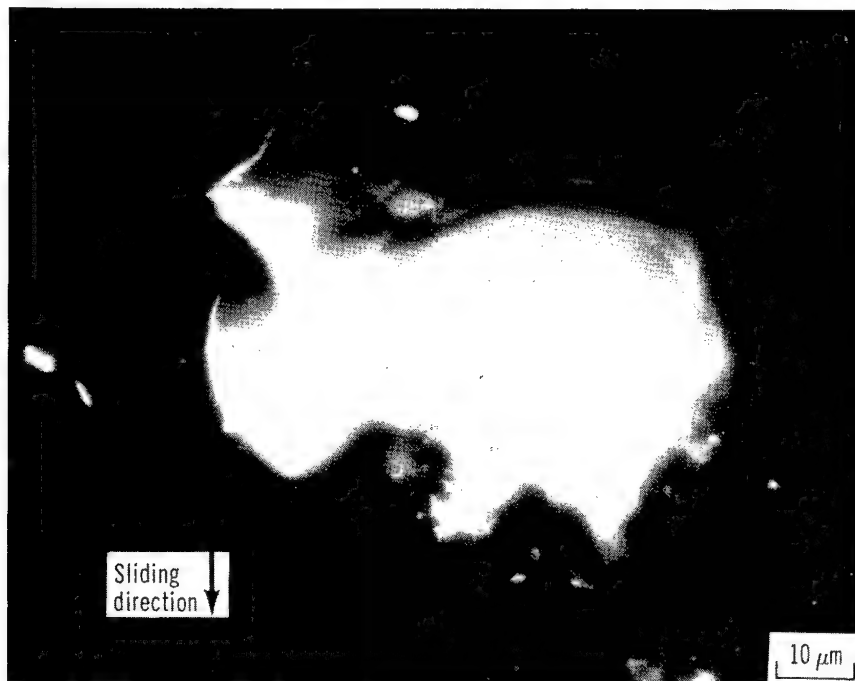
Figure 4. - Large fracture pit of single-crystal silicon carbide in contact with 8.12 atomic percent Ti-Fe alloy as a result of ten passes of rider in vacuum (10^{-8} Pa). A scanning electron micrograph of wear track on silicon carbide (0001) surface. Sliding velocity, 3×10^{-3} meter per minute; load, 0.2 newton; room temperature.

Figure 4 presents a scanning electron micrograph of a wear track on a silicon carbide surface accompanied by an exceptionally large fracture pit. A large light area at the beginning of wear track is a fracture pit where the wear track was generated by 10-pass sliding of a 8.12 atomic percent titanium-iron alloy rider across the surface. Most of the silicon carbide wear debris has already been ejected from the wear track. The smooth surface at the bottom of the fracture pit is due to subsurface cleavage along $\{0001\}$ planes.

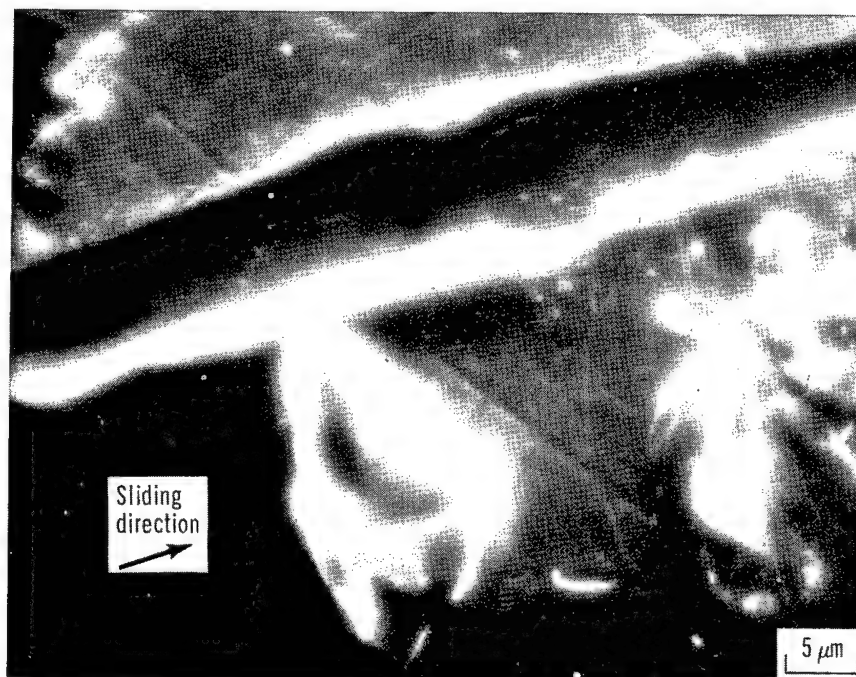
(a) Grooves and spherical indentations.

(b) Groove.

Figure 9. - Grooves and indentations formed by plowing and indenting of spherical wear debris as result of ten passes of rider in vacuum (10^{-8} Pa). Scanning electron micrographs of wear scar on 1.02 atomic percent Ti-Fe alloy rider. Sliding velocity, 3×10^{-3} meter per minute; load, 0.2 newton; room temperature.

Figure 9 consists of scanning electron micrographs of rider wear scars after sliding against a silicon carbide surface. These figures reveal spherical indentations and straight grooves along the sliding direction on the rider surfaces formed by indenting and plowing the spherical wear debris. Such a spherical wear particle and its indentation and groove were primarily observed for the alloys with low solute concentrations presented in table II. These results reveal that (1) a nearly spherical wear particle can be produced by sliding friction, (2) the wear particle plows the surface of the alloy rider during sliding, that is, the hardness of the particle is much greater than that of the alloy rider surface, and (3) the wear particle includes the element of silicon, as shown by the X-ray map of Si K_{α} . The next question is what is the real

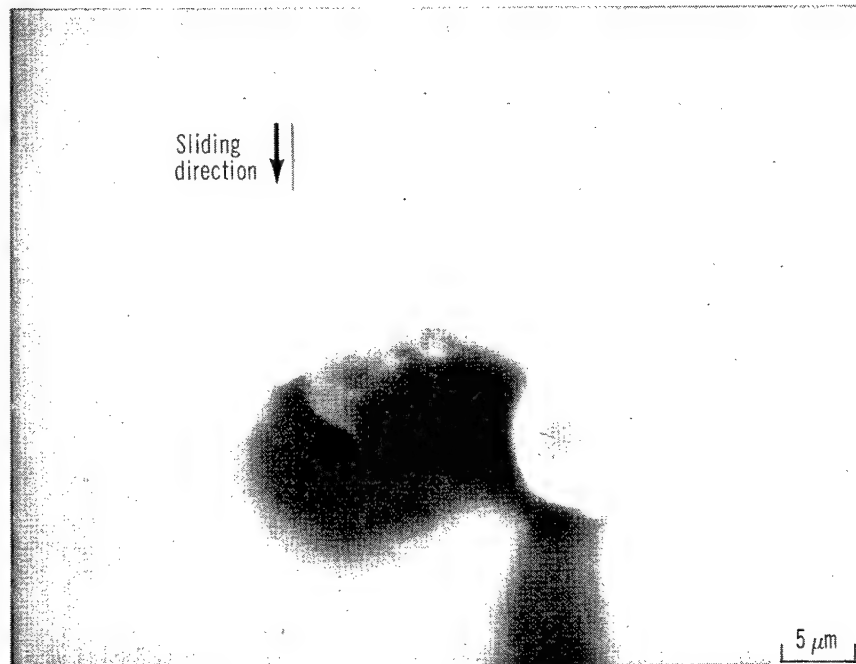
(a) Spherical wear particle.

(b) Spherical and multiangular wear debris.

Figure 10. - Spherical and partially spherical wear particle as result of ten passes of 1.02 atomic percent Ti-Fe alloy riders in vacuum (10^{-8} Pa). Scanning electron micrographs of wear tracks on disk. Sliding velocity, 3×10^{-3} meter per minute; load, 0.2 newton; room temperature.

(c) Partially spherical and partially multiangular wear particle.

(d) Partially rounded and partially multiangular wear particle.

Figure 10 shows partially spherical wear debris particles observed on the silicon carbide surfaces in sliding contact with the 1.02 atomic percent titanium-iron alloy rider. The nearly spherical particles are very similar to the particle observed on the wear scar shown in figure 8. The partially spherical wear particles include a multiangular and a spherical portion. Partially spherical wear particles were also observed with the multiangular wear debris particles on the wear scar of the alloy, as shown in figure 11.
